THERMAL PROBLEMS CAUSED BY HARMONIC FREQUENCY LEAKAGE FLUXES
IN 3-PHASE, 3-WINDING CONVERTER TRANSFORMERS

J. Alan C. Forrest
Senior Member IEEE
Teshmont Consultants Inc.
Winnipeg MB
Canada

Bill Allard
Associate Member
Vermont Electric Power Co.
Rutland VT
USA

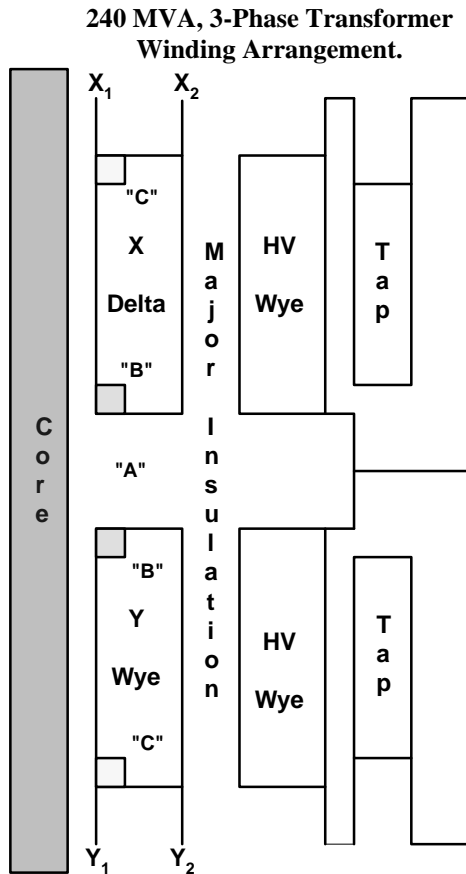
Figure 1

This was the transformer that had failed in service. The failure had occurred at the bottom of the top LV (or delta) winding in the inside layer of one phase. It would be expected in the case of the failure in a large transformer, that most of the evidence, in this

case of overheating, would be destroyed or masked by the short circuit itself. However, in this transformer there was ample evidence of damage to the insulation as a result of overheating. Damage had occurred not only on the other end of the faulted winding, but also on the other LV winding on that phase, and on all the LV windings on the phases.

The three end turns at the top and bottom of both LV windings had been provided with extra insulation. The examination showed that these end turns had been subject to damage as a result of overheating, and that the damage had been greatest at the centre of the leg where the two LV windings are adjacent, close to point "A" in Figure 1. The damage was most extensive on the end turns on the inside layer, and was worse on the top or delta winding than on the bottom or wye connected winding point "B" in Figure 1.

At the other, or outer end of the LV windings there were also signs of damage due to overheating but to a much lesser extent (point "C" in Figure 1).

The dimensions of the replacement LV windings were constrained by the size of the original LV windings. The LV windings were re-designed with much smaller conductors and a larger number of conductor strands. All of the additional insulation on the end turns except for a single pressboard angle ring were dispensed with. The temperature rise test on the first repaired transformer was satisfactory, the average winding rise on the delta connected LV winding was reduced by 5.5°C compared with the original design. This was achieved in spite of an increase in the I^2R loss still using CTC conductors. These conductors have a larger number of parallel strands, occupy the same space, with each strand being smaller than the original. This results in a slightly higher average current density. However, there was an overall reduction in stray loss, both the normal "60 Hz" stray loss plus the harmonic loss, that more than compensated for the increased I^2R loss. As well as redistributing the losses and decreasing the total load loss in the LV windings, the cooling was also improved by eliminating the additional insulation on the end turns of the LV windings.

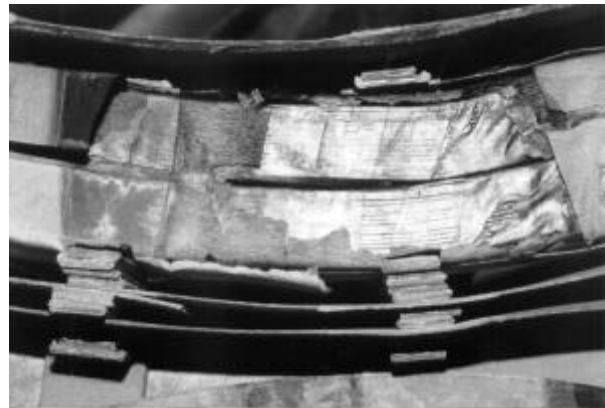
Figure 2

The second transformer also carried the same LV currents as the first unit for the first eleven years. In addition it had been in service for eight months longer. As expected the degree of overheating damage was greater. This unit did not fail in service but was repaired based on the findings of the investigation into the failure of the first transformer. Other than the faulted area in the first transformer the pattern of damage in the two transformers was the same. For example the continuously transposed conductor enamel at the bottom of the top winding in the second unit had become completely carbonized and in effect had fused with the remains of the overall paper insulation "outside" it. A photograph of the damage to the bottom of the delta LV winding on phase 2 is shown in Figure 2.

Damage at the bottom of Delta LV winding
