THERMAL PROBLEMS CAUSED BY HARMONIC FREQUENCY LEAKAGE FLUXES
IN 3-PHASE, 3-WINDING CONVERTER TRANSFORMERS

J. Alan C. Forrest
Senior Member IEEE
Teshmont Consultants Inc.
Winnipeg MB
Canada

Bill Allard
Associate Member
Vermont Electric Power Co.
Rutland VT
USA

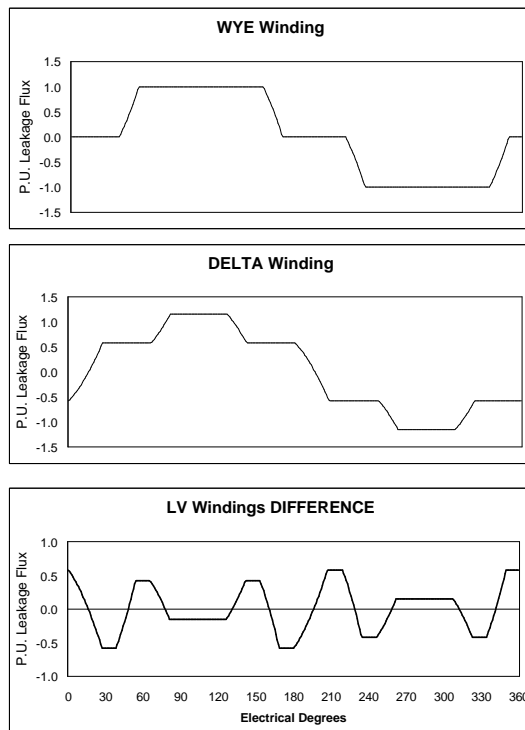
Electrical Degrees
Valve Windings Leakage Fluxes
Figure 3

leakage flux in the two windings will be different. The difference in leakage flux between the two windings with the normal operating firing angle of 20° and overlap angle of approximately 16° , is shown in Figure 3. The waveforms and magnitudes of the valve winding phase fluxes are shown at the top and centre of Figure 3. In the case of the delta while the current is reduced by a factor of $1/3$, the number of turns is $\sqrt{3}$ larger and hence the flux Φ

becomes as shown. The difference between these fluxes is shown at the bottom of Figure 3. Note the wye winding leakage flux is taken as 1.00 and the 60 Hz fundamental frequency component of this flux is $\pi/\sqrt{6} = 1.28$ p.u. This calculation shows that there will be a difference in the RMS leakage flux amounting to some 44.8% of the normal 60 Hz transformer leakage flux. The waveform of this flux has 300 Hz and 420 Hz components of 37.1% and 23.2% respectively, plus some higher harmonics. Due to the difference in the phase angle of the harmonic currents of the two LV windings, this flux difference is prevented from linking both LV windings. Due to the low reluctance of the core the flux passes between the two LV windings and enters the core steel. This flux can affect particularly the end turn of each winding in the "gap" between the windings, and because of the high harmonic content it may cause localized heating of the winding conductors due to induced eddy currents.

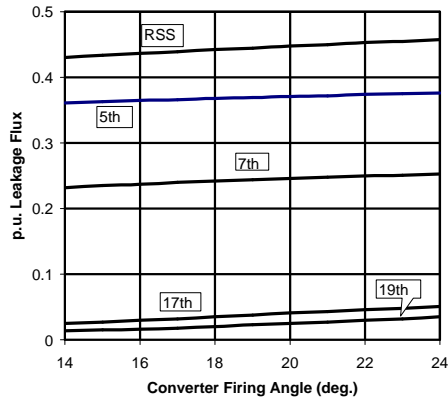
The Highgate converter transformers have a 12.7% reactance and the normal firing angle of the converter is about 20°. For these parameters the RMS value of leakage flux difference in the LV's at full load is 44.8%. The difference in the leakage fluxes will exist in all converter transformers regardless of the design. On large single-phase transformers, the LV windings are usually on separate core legs, and the individual LV winding leakage fluxes will return to the core and not create a problem. But on converter transformers with two same diameter LV windings on one core leg, the difference in the two leakage fluxes has to exit between the two LV windings. Calculations were made for range of operating firing angles of 14° to 24° and the difference in leakage flux in the LV's varied from 46.5% to 43.3%. The RSS value of the leakage flux and the chief constituent harmonic components as a function of firing angle are shown in Figure 4.

Converter Firing Angle (deg.)
Harmonics as a function of Firing Angle
Figure 4

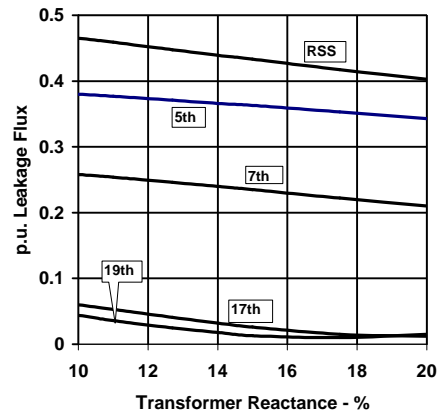
harmonics in the difference leakage flux as well as the RSS of the resultant is shown in Figure 5.

Harmonics as a function of Reactance
Figure 5

The results indicate that, within the range of practical transformer reactances and the normal operating firing angles of HVDC converters, the difference in leakage flux in the LV's only varies by some 15% and for general converter transformer design use may be taken as 45% for practical purposes. The 5th and 7th harmonic components may be taken as 37% and 25% respectively.

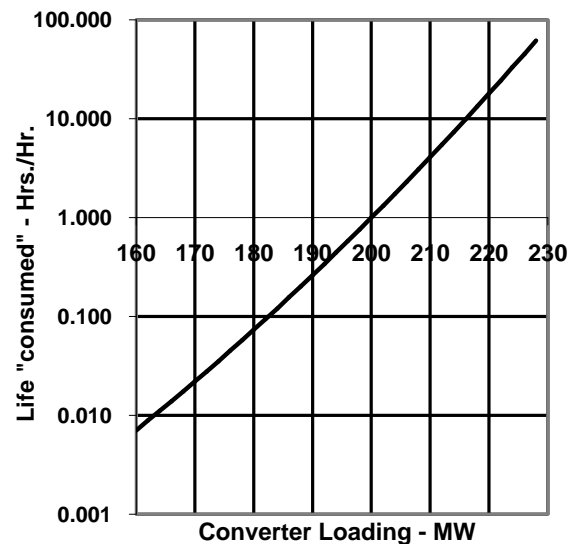
Taking the nominal converter loading of 200 MW as the reference, 160 MVA for one hour would produce the same amount of insulation deterioration as 200 MW for 36 seconds, while 120 MVA for one hour would produce the same amount of insulation change as 200 MW for 15 hours. The cause of life "consumed" against MW loading shown in Figure 6.

Life "Consumed" during operation
Figure 6

The "straight line" plot of T_{200} against F_h is shown in Figure 6. The values of F_h from 7 to 10 covers the range generally referred to in the literature. In Reference 3 for insulation temperatures above 120°C, the value of F_h is 8°C. From our calculations this gave one "chosen value" of T_{200} of 159°C. This appeared to be consistent with the damage that was found in the transformers.

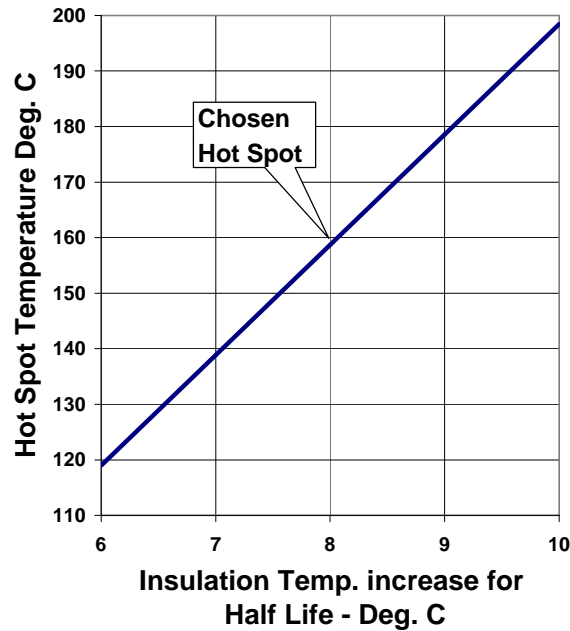
insulation half-life temperature "rise" gave the curve shown in Figure 7.

According to McNutt, [Reference 3] for insulation temperatures over 120°C, an 8°C-temperature increase halves the insulation life. For this half-life, Figure 7 gives a hot spot of 159°C. It is felt that this corresponds reasonably to the temperature required to produce the winding insulation deterioration that was observed.
